Splitter Box Cleaned While In Operation

22-Cubic Yards of Sand Removed

CENTRAL FLORIDA

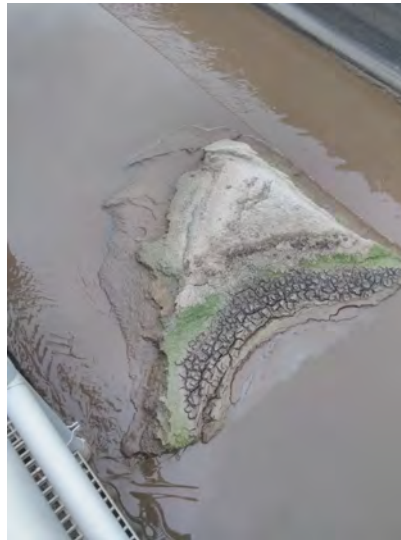
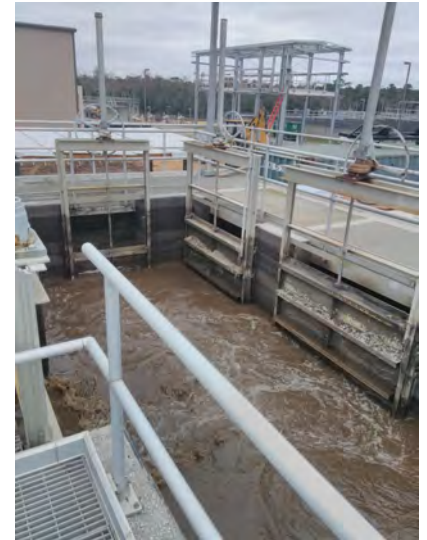
Wastewater treatment facilities typically employ a splitter box to separate influent flow to various structures such as aeration basins or clarifiers. This Central Florida splitter box had a visible level of sand above the water line that needed to be cleaned, and the structure measured approximately 40-feet by 25-feet. The utility was also unable to divert flow or take the structure offline, adding another level of complexity to the project.

USST crew mobilized to the site, bringing with them a powerhouse of equipment, the Combination³® Truck, outfitted with extended boom, downhole pump, and jetter. While the splitter box was in full operation, USST utilized the GritGone Process® to remove sand and grit material.

22 total cubic yards of sand and grit was removed from the splitter box. Because the box did not have to be taken offline or drained down, risky confined space entry was not necessary.
